Posterior Cervical Decompression and Fusion C3 – 6 with lateral mass fixation

# HENSLEER SURGICAL

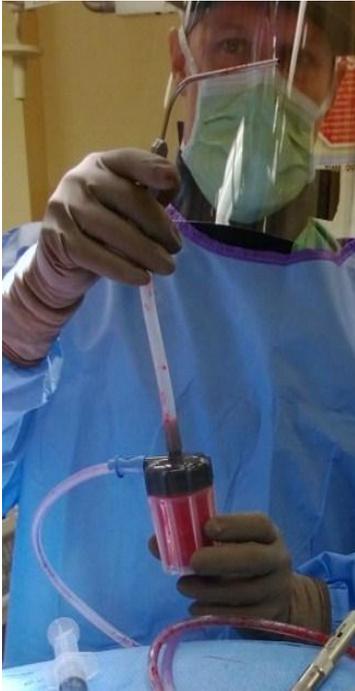
To the left: This is the collection stage setup. Frazier suction tip attached to the silicon tubing, Operating Room (OR) provided suction source and tubing, which attaches to the side port of the collection top. We irrigated throughout the entire drill phase.

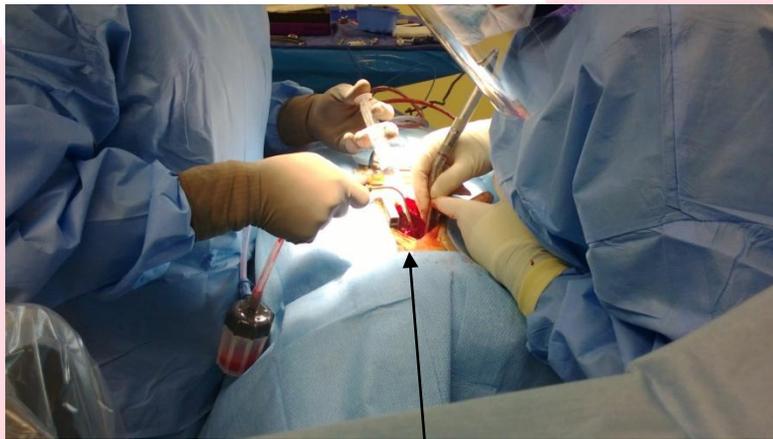
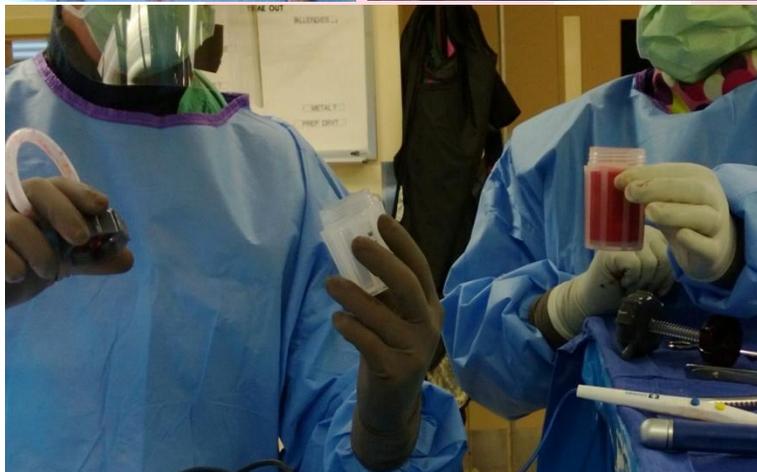
Above: High speed drill and collection. We used a 30 mm cutting burr.

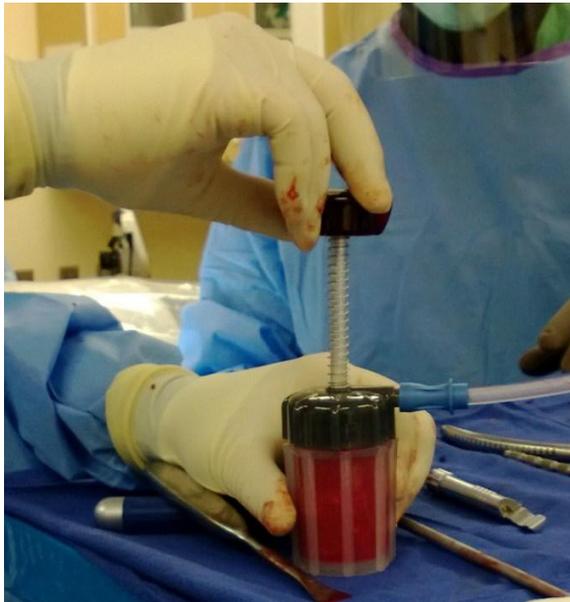
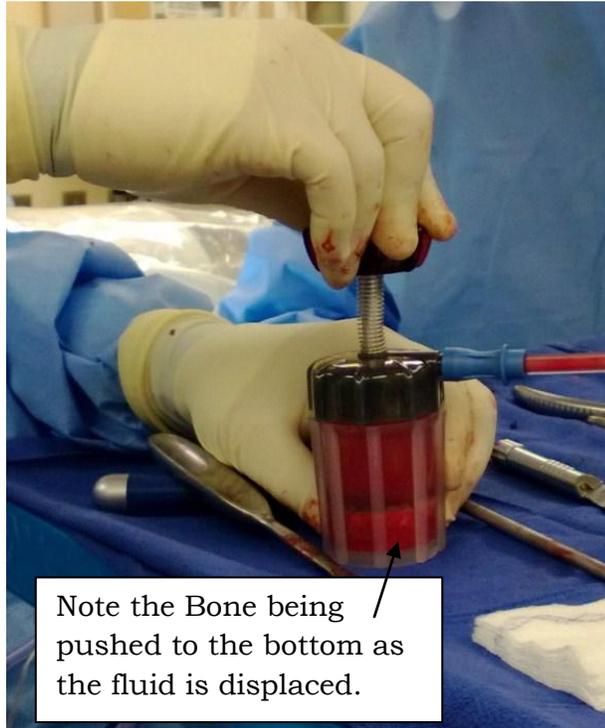
To the Left: The transfer. I handed the full container to the scrub tech. She took it and handed me back an empty container. I re-attached and resumed the case for addition bone collection.

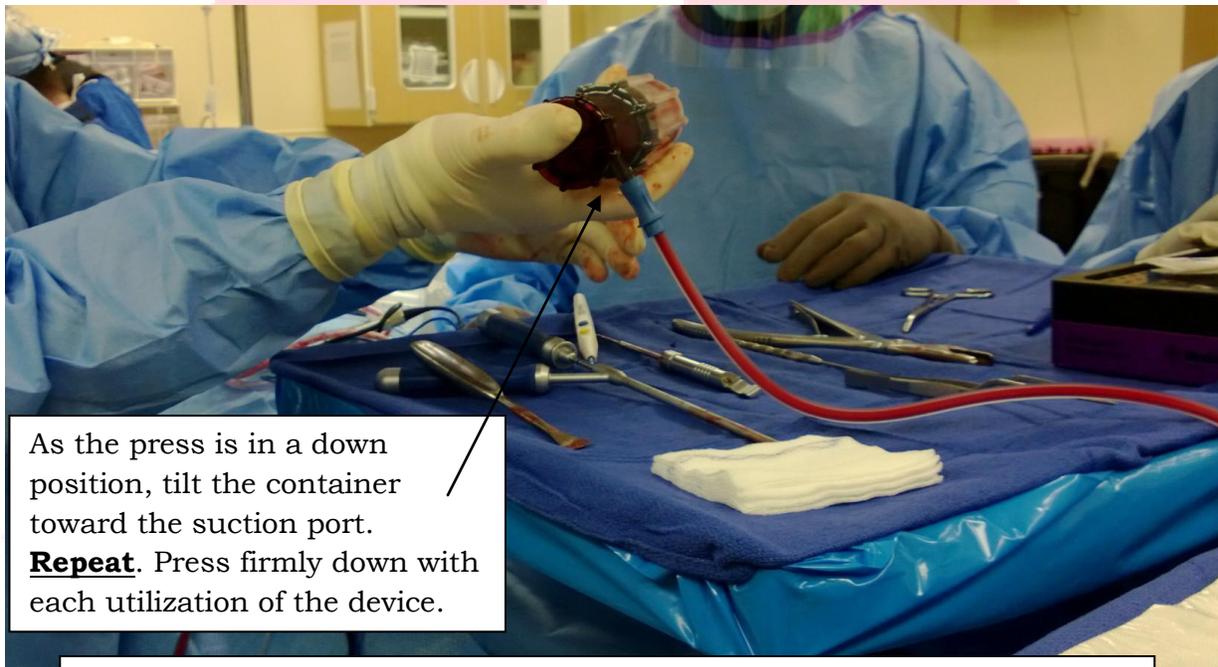
Above: I was collecting again at this point. The scrub tech took the full container, attached the press top, attached the suction to the side port and begun the press. **ENSURE THE SUCTION IS OPERATIONAL.** Press and tilt. Blood and irrigation was suctioned away effortlessly. We pressed twice and tilted to ensure bone was well compressed.

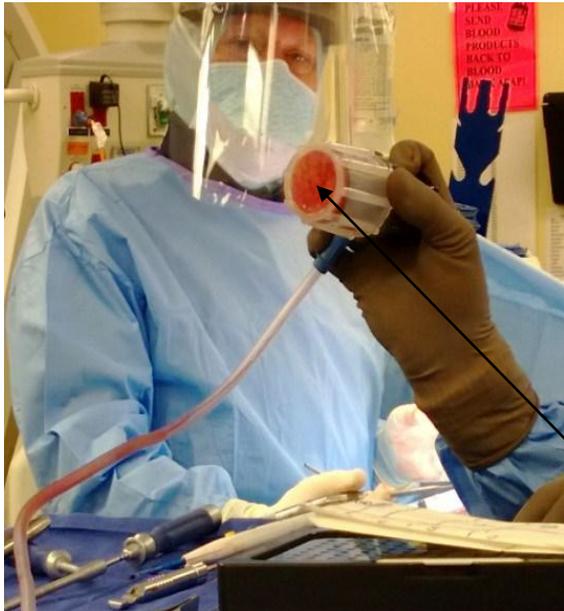
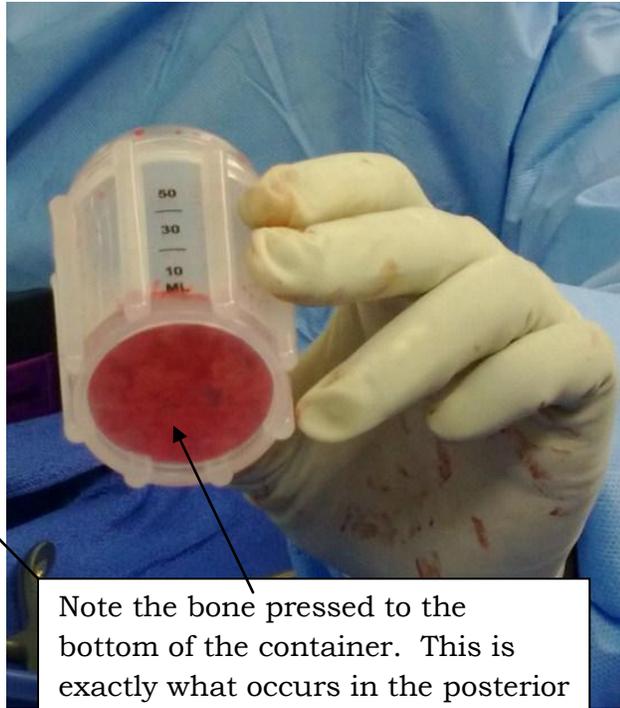
Note the bone pressed to the bottom of the container. This is exactly what occurs in the posterior lumbar cases as well.

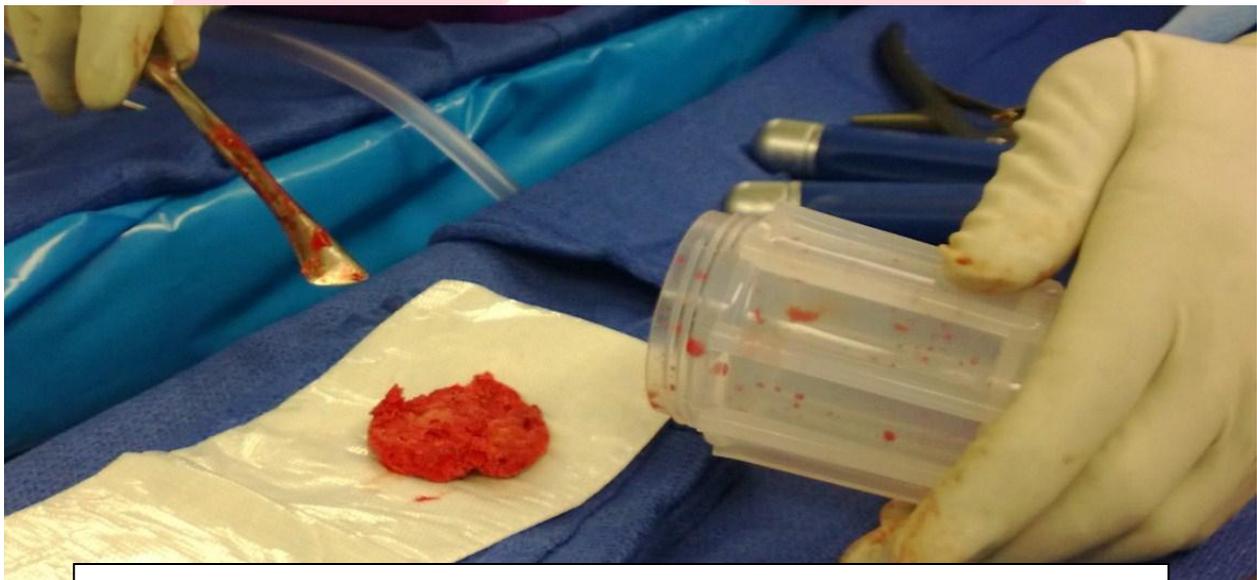
Above: After the press and tilt action, the bone patty fell right out of the container. Press firmly down to the bottom and repeat to ensure maximum dryness and compression. We had a periosteal ready to go, but we didn't need it. The bone was ready to be formed and utilized immediately. The graft texture was perfect as you can see. *Moldable **AND** malleable.*

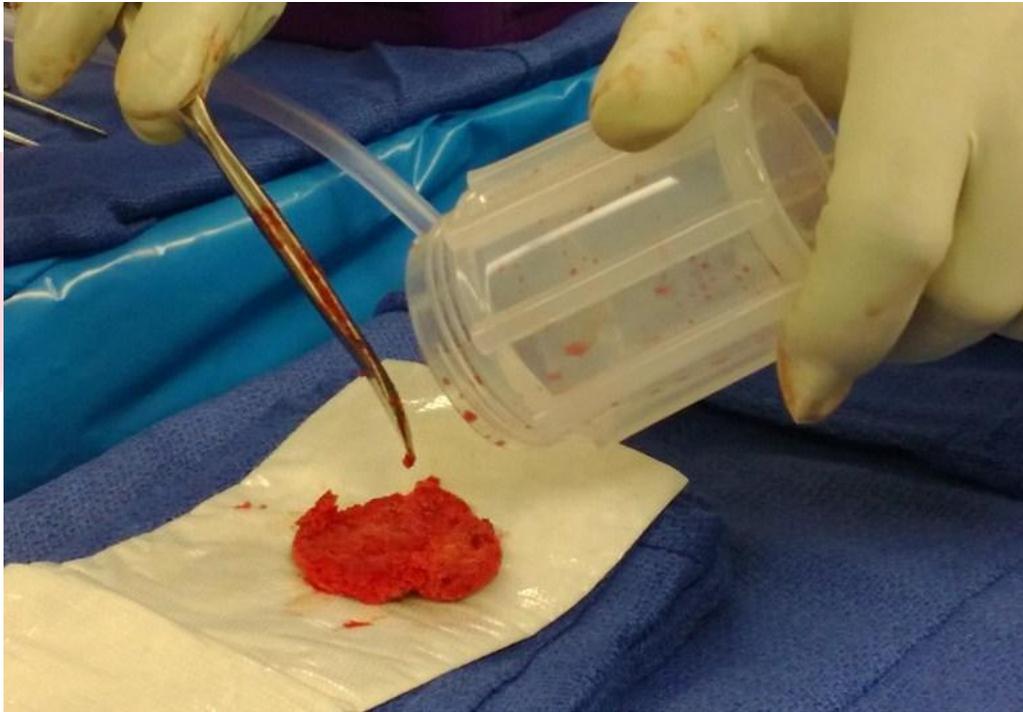
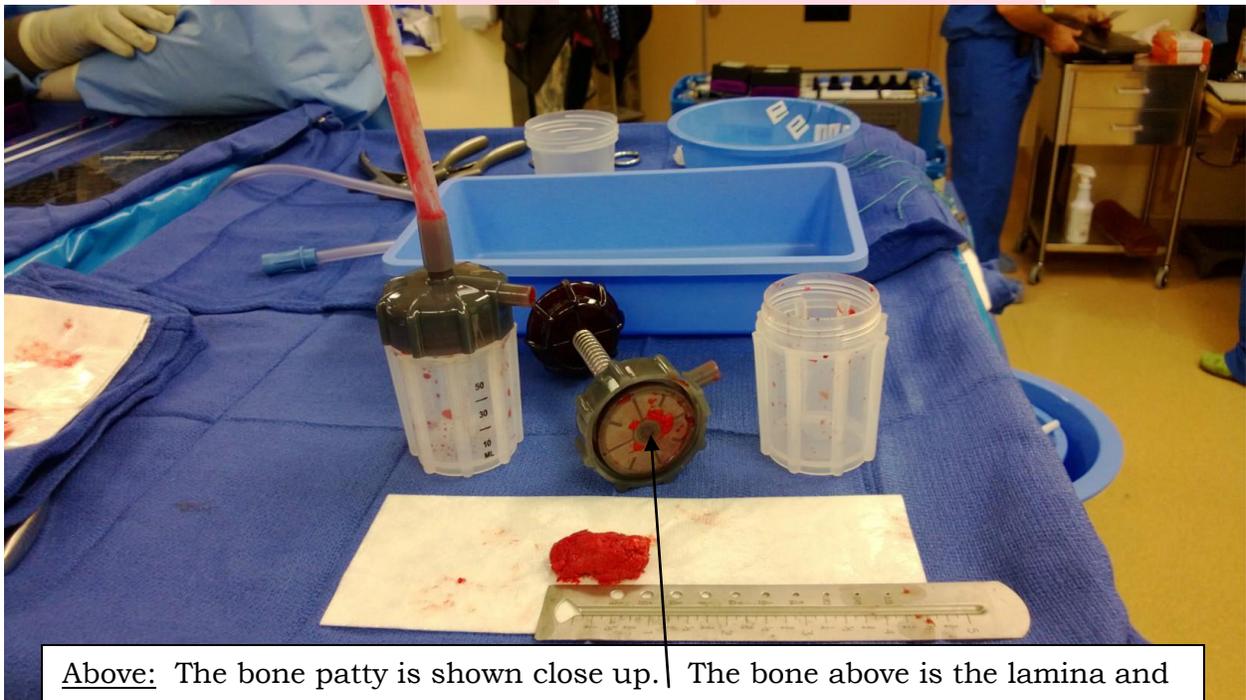
Above: The bone patty is shown close up. The bone above is the lamina and lower spinous process' C3-6. The bone on the screen easily was removed with a periosteal. Although the screen is medical grade stainless steel, use caution with a sharp instrument. WE haven't had an issue with a periosteal, but regardless, use your best judgment and common sense.

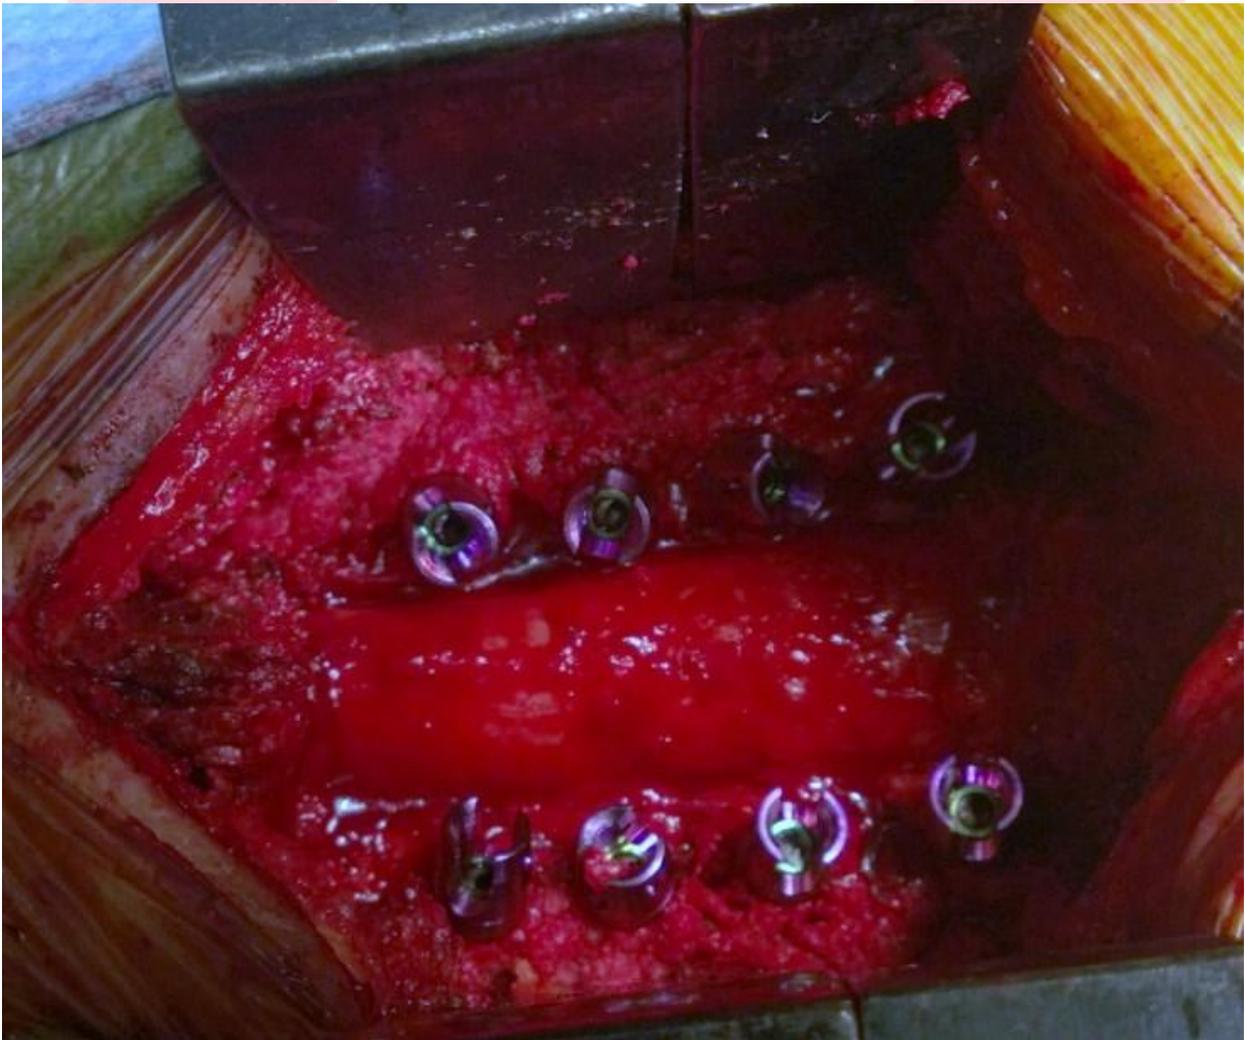
**The bone graft was placed nicely in the gutters and around the hardware for the  
fusion.**
